Prospective Study on CAD/CAM Nano-Ceramic (Composite) Restorations in the Treatment of Severe Tooth Wear

J Adhes Dent 2022; 24: 105–116.
doi: 10.3290/j.jad.b2838137

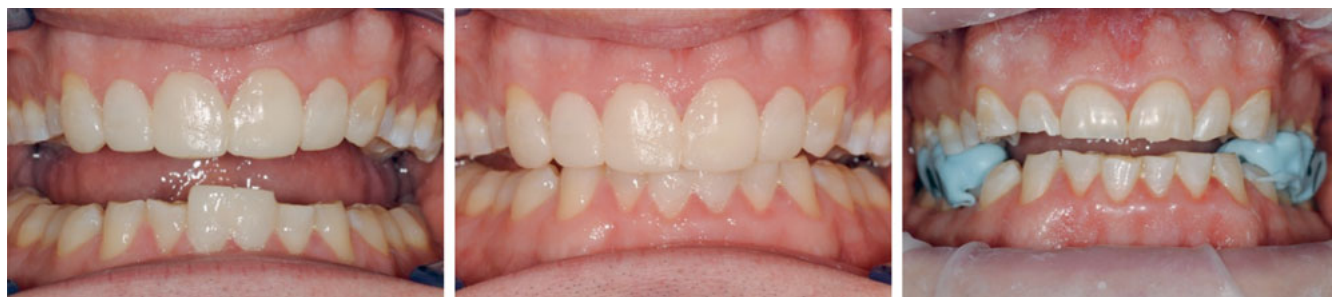
Fig 1 Mockups on the maxillary and mandibular anterior teeth and silicon stops in situ to preserve the new VDO.

A minimally invasive tooth preparation was performed. It comprised removal of sharp edges and a shallow chamfer to determine the outline for the dental technician (Fig 2). In selected cases, and especially in lingual surfaces of anterior teeth, seats were prepared where otherwise no “resistance”³⁴ of restorations could be obtained and seating of restorations could be enhanced. Intraoral 3D-scans (True Def IOS, 3M Oral Care) were made, including bite registration in the increased vertical dimension, while intraoral stops were placed in situ to mimic the desired, predetermined VDO.

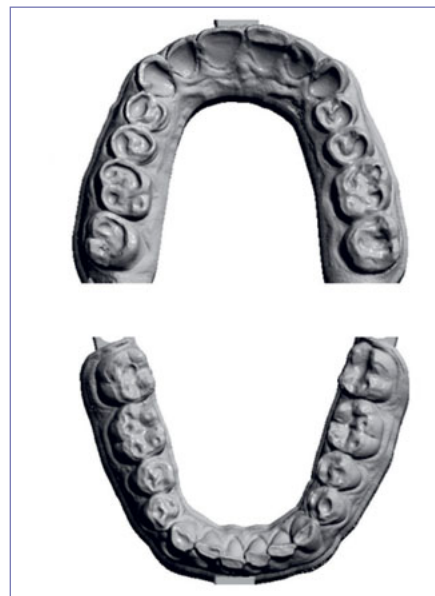
Fig 2 3D scan after preparation.

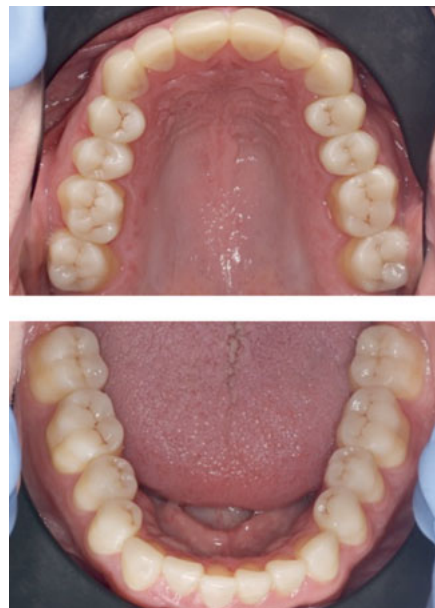
Fig 3 Maxillary and mandibular arches after placement of CAD/CAM composite restorations and facial veneer restorations.

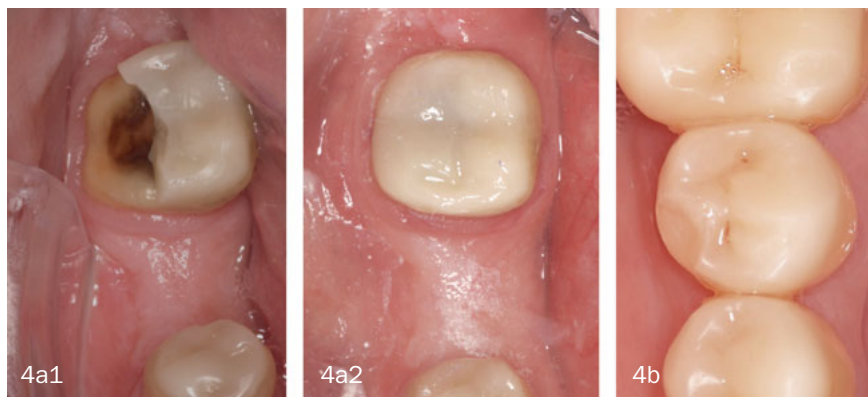
Fig 4a Adhesive fracture (1) and the repair (2) of restoration on tooth #47.

Fig 4b Chip fracture of restoration on tooth #35.

- restorations with severe deficiencies that were replaced, or in case of an extracted abutment tooth;
- restorations with localized deficiencies that were repaired, or when a completely debonded restoration could be recemented (Fig 4a);
- restorations with small material chippings that received either refurbishment by polishing or needed no intervention (Fig 4b).
