Surface properties of nickel-titanium rotary instruments

Key words *autoclave sterilisation, corrosion, NaOCl, NiTi, surface treatment*

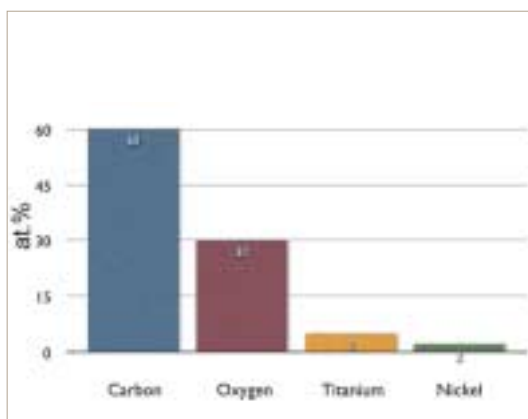
Fig 2 Surface analysis of NiTi instruments: given are the atomic ratios (%) of the different elements.

ments. In fact, along with Ti and Ni, C, O and other components (Si, Ca, Mg) were observed due to environmental contamination¹⁶ (Fig 1). Since the surface of the NiTi instrument is in contact with air containing oxygen and carbon, the concentration of nickel and titanium increases from the surface towards the core. A typical surface analysis of NiTi instruments is: C (62%), O (30%), Ni (2%) and Ti (5%) (Fig 2). A Ni/Ti surface ratio of 0.30 was observed with NiTi instruments.

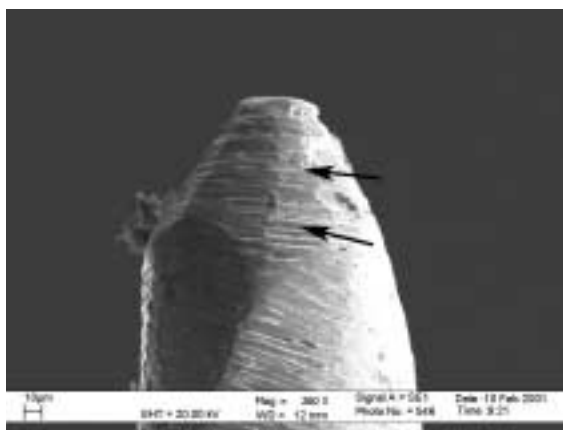
Fig 4 Presence of metallurgic defects (micro-cracks, machining marks and metal flash) on the surface of a new NiTi instrument (indicated by arrows).

the surface of NiTi instruments^{19,20} (Fig 4). For this reason, many authors suggest that new rotary NiTi instruments should be cleaned with ultrasound before clinical use and sterilised in order to eliminate any metal residue and surface debris²¹⁻²³.

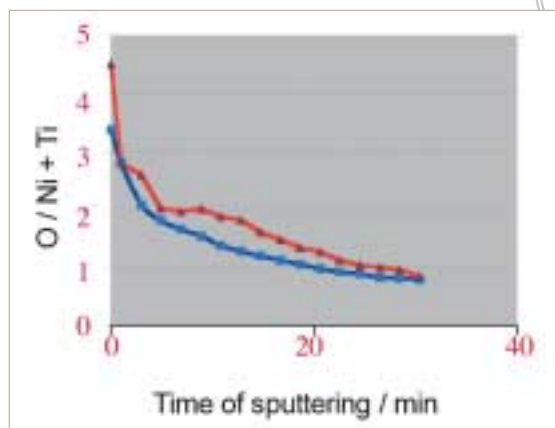
Fig 5 An increased amount of oxygen was observed on the surface of NiTi instruments after autoclave sterilisation (red line) compared with new instruments (blue line). The time of sputtering relates to the sampling depth of the surface of the instruments.

Autoclaving, especially when repeated, increases the quantity of oxygen present on the surface of NiTi instruments (Fig 5) and creates conditions that reduce their cutting efficiency (Fig 6)¹⁶. According to these studies, repeated autoclave sterilisation of

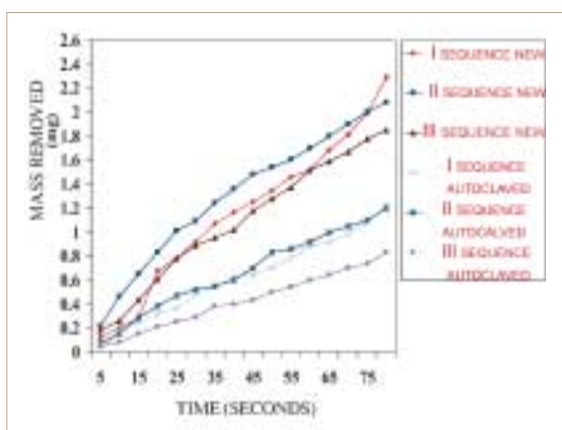
Fig 6 Decreased cutting efficiency of NiTi instruments after sterilisation processes. Unsterilised and sterilised NiTi instruments were used under identical conditions, on resin surfaces, and the removed mass of resin recorded. The sharper the cutting edges of the instruments, the greater was the material removal. Obviously, even if they were used for two or three sequences, unsterilised new instruments removed a markedly greater mass compared with sterilised instruments. The cutting efficiency of sterilised instruments decreases with an increasing number of sterilisation cycles.

endodontic NiTi instruments has been shown to adversely affect the cutting efficiency of these instruments (Fig 6). In particular, files that underwent five cycles of sterilisation experienced a reduction in cutting ability of approximately 16.1% compared with untreated files. After 10 cycles of sterilisation, the cutting efficiency was further reduced by up to 50.8%¹³. The explanation for these undesirable effects of sterilisation may be that sterilised instruments undergo changes on their outer surfaces and in the chemical composition of the surface layer. It was observed that sterilisation produced an increase in titanium oxide (TiO₂) in the near-surface layer of the instruments¹⁶.

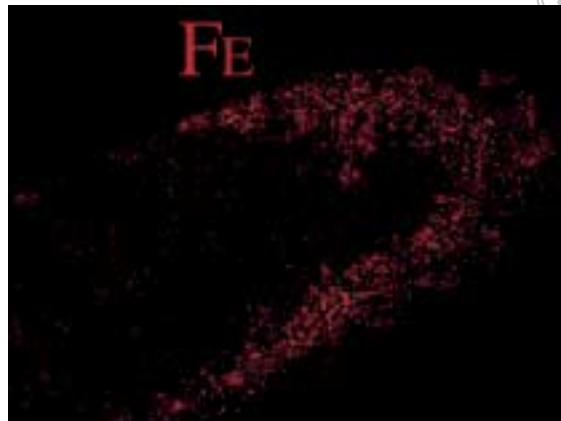
Fig 10 Presence of Fe deposits on the tip of a NiTi instrument after NaOCl treatment.

electrolytic solution such as NaOCl. In addition, NaOCl solutions initiated a widespread chemical oxidation on the surface of the instruments. In the case of NiTi instruments, the oxidation process could not be accurately assessed since oxide constituents were already present on the surface. However, these instruments an increased quantity of depositions (NaOCl residues, oxides and metal deposits) was observed in the surface defects (milling marks, groves and micro cracks) (Fig 9). Therefore, it seems that NaOCl more easily corrodes the minor surface defects already existing on the surface of non-electropolished instruments (see below) and may thereby weaken the instruments. It is worth mentioning that in this study, pitting and corrosion occurred on the shaft of the instruments, while no marked corrosion was observed on the flutes or near the tip of the instruments. At first sight, these results seem to disagree with the observations of other studies evaluating corrosion processes on ProTaper and GT Rotary NiTi instruments^{15,33}. However, after careful analysis these differences can be explained as follows: ProTaper and GT Rotary NiTi instruments have shafts coated with gold, which possess a high redox potential ($E^{\circ}_{Au^{3+}/Au} = +1.50$ V). This property causes the shaft to behave as a cathode, and the Ni-Ti cutting part ($E^{\circ}_{Ni^{2+}/Ni} = -0.25$ V and $E^{\circ}_{Ti^{2+}/Ti} = V$) as the anode at which corrosion arises³⁴. In contrast, the shaft of RaCe instruments is made of stainless steel in which iron ($E^{\circ}_{Fe^{2+}/Fe} = -0.74$ V) possesses a lower redox potential than the cutting part made of NiTi. Therefore, the corrosion occurred on the shaft (the anode) and Fe is deposited on the NiTi alloy

(Fig 10). In particular, larger amounts of deposit were observed at the tip region of the instruments, because it is known that the end of the tip induces a higher current density.

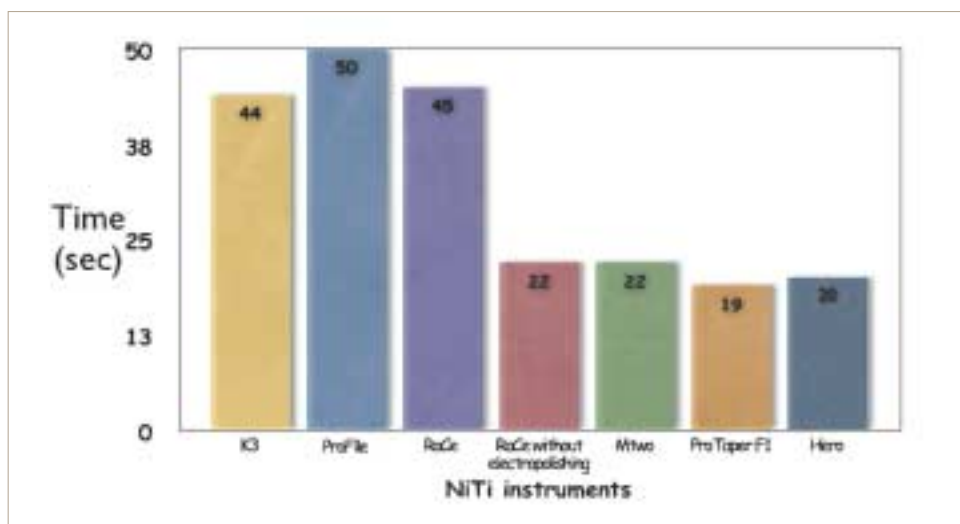
Fig 12 Fatigue resistance of different rotary NiTi instruments: mean values of fracture time (seconds) for each type of instrument are given.

A recent study revealed that untreated NiTi RaCe instruments displayed similar fatigue resistance times compared with Hero and Mtwo files, but shorter times than ProFile and K3 files¹⁸. These findings strongly indicate that instruments having triangular cross sections with sharp cutting edges do not have the same flexibility as files with a U-shaped cross-

sectional design. However, it should be remembered that the surface of the commercially available RaCe instruments is treated by an electropolishing procedure, which reduces the presence of machining damage on the file surface and increases the fatigue resistance to values comparable to ProFiles (Fig 12).
