Int Poster J Dent Oral Med 2004, Vol 6 No 03, Poster 238

Failure mode of implant-abutment connections after horizontal cyclic loading

Dipl.-Ing. Holger Zipprich,
OA Dr. Paul Weigl,
ZÄ Silke Fischbach-Sedlatschek,
Prof. Dr. Hans-Christoph Lauer,
Department of Prosthetic Dentistry,
Johann-Wolfgang-Goethe-University Frankfurt am Main

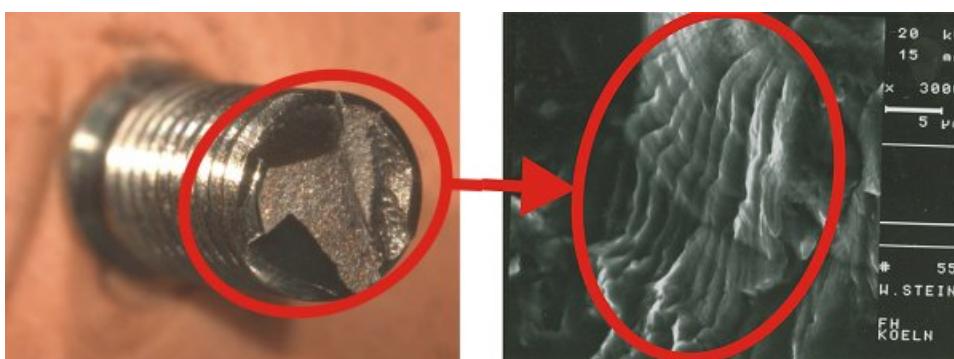
In-vivo implant fracture with cycle loading caused fatigue striations

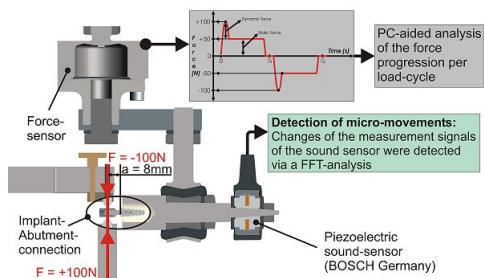
Experimental Parameters of the chewing simulator

Force [N]	Frequency [Hz]	cycle loadings n	loading weight [kg]	distance [mm]	speed [m/s]
± 100	2	1.000.00000	5	± 1.5	40

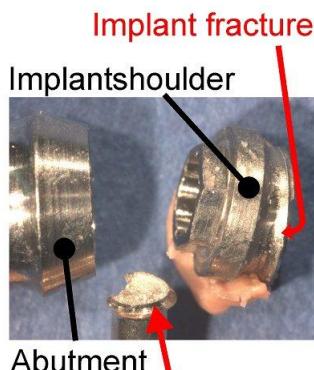
Brånenmark

Goldscrew fracture
without plastic
deformation

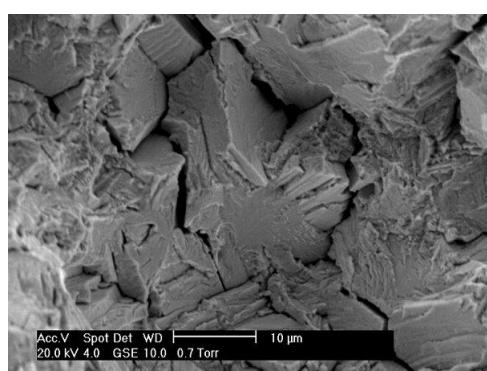
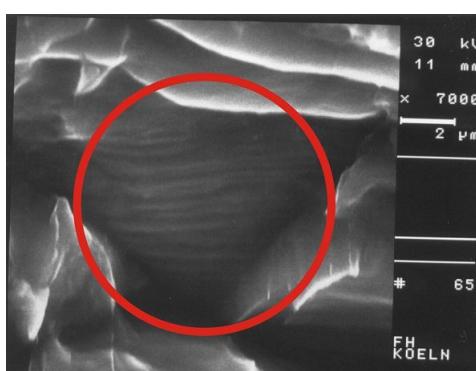
Embrittlement at fracture surface of the goldscrew

Cycle loading caused fatigue striations at fracture surface of the Implant

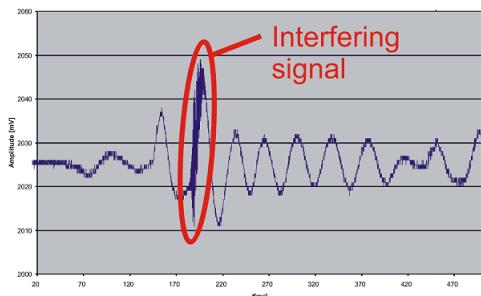
ITI-SynOkta
milling cylinder

Signal in course of time of a loosened ITI suprastructure

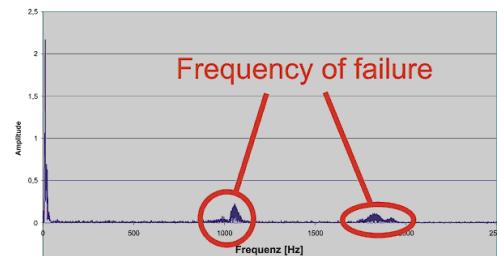
Frequency spektrum of a loosening ITI Supra structure

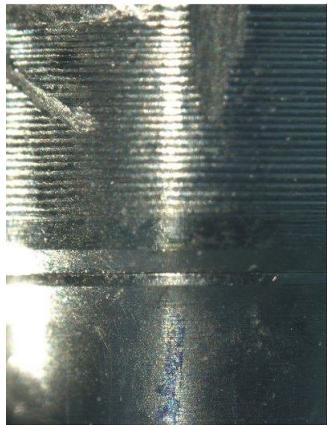
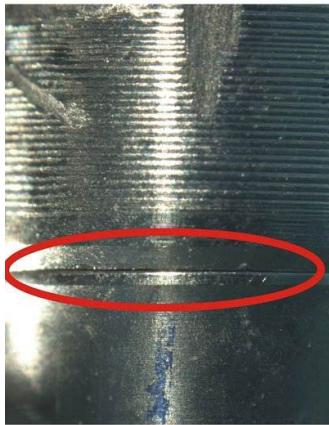
$F = 0\text{N}$

$F = 100\text{N}$

Dumping of suprastructure

Virgin connection

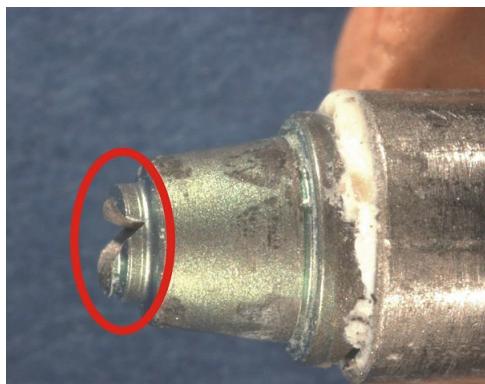
ITI-WN-massive Abutment
Screw fracture

Caused by incongruent conical surface

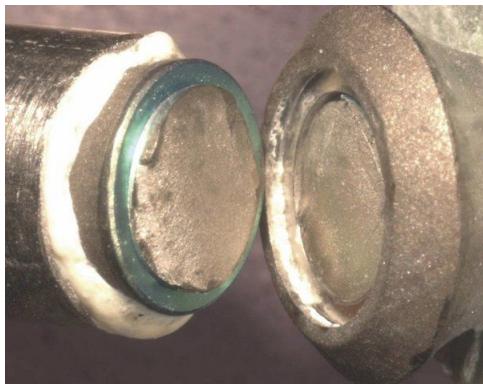
= Flaw. \Rightarrow Abutmentfracture

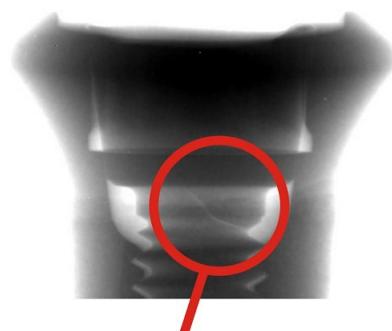
Cracked screw

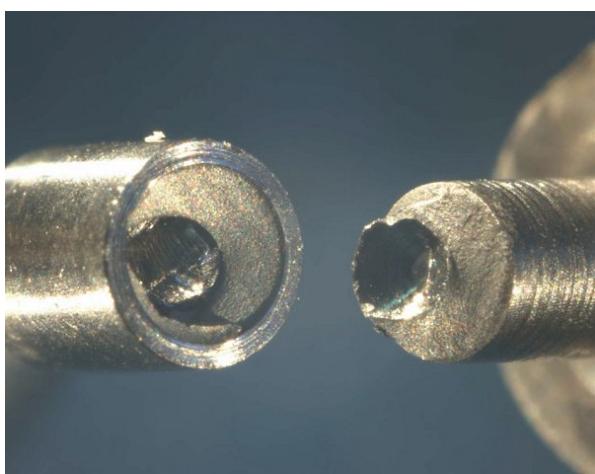
Impla
Screw fracture

Caused by undersized Screw

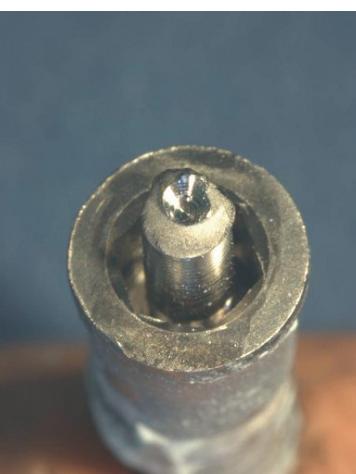
5 of 6 fractured screws are easy to remove

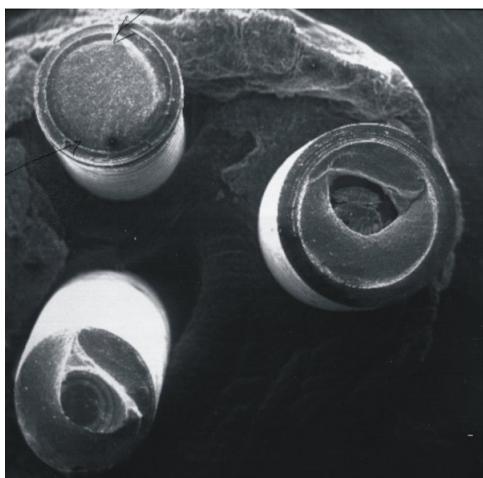
At 1 of 6 fractures second fracture at the beginning of thread

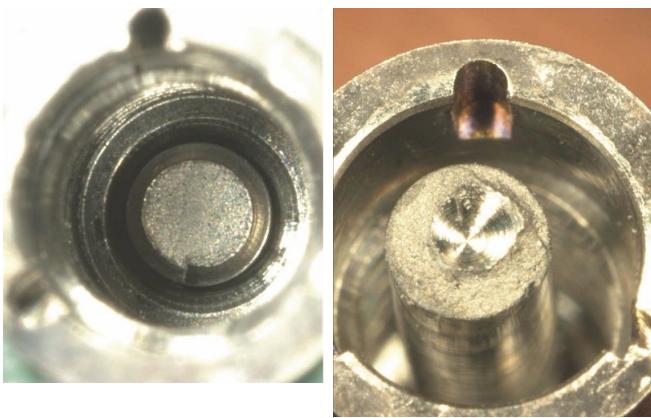
Camlog
Fracture of both Screws

Connection after 1.000.000 cycles

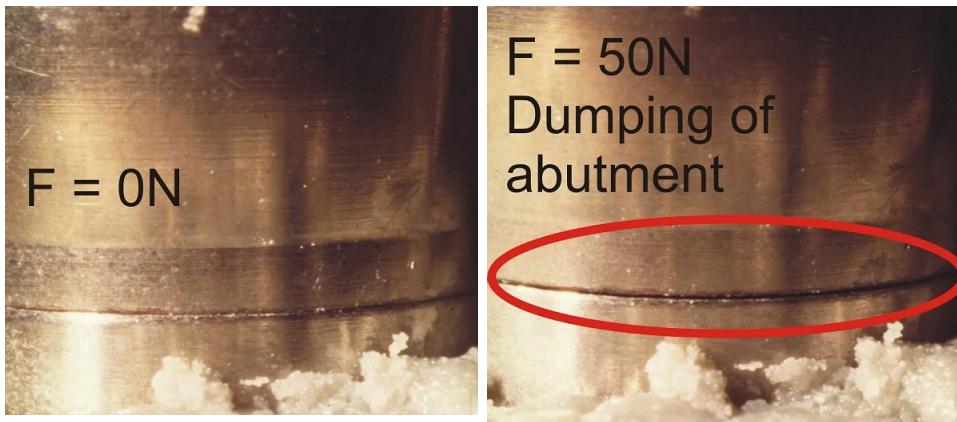
Screw cracked

caused by
loosening

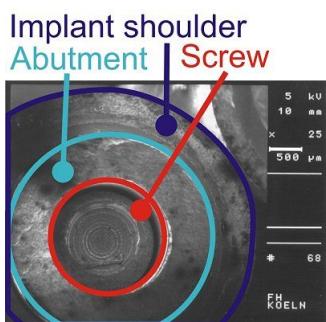
Frialit 2
Fracture of connection:

Failed abutment is
difficult to remove

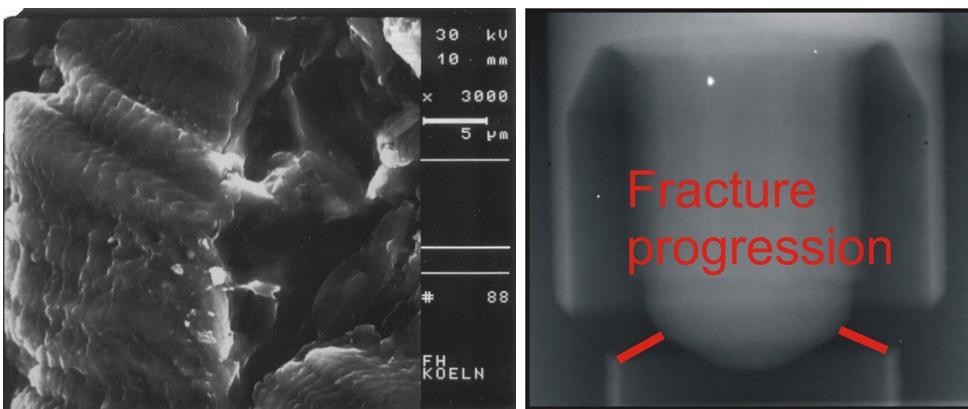
Cycle loading caused fatigue striations

Undersized screw

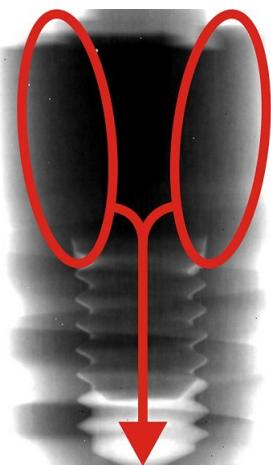
Ankylos
Before cyclic loadings

Congruent conical surface

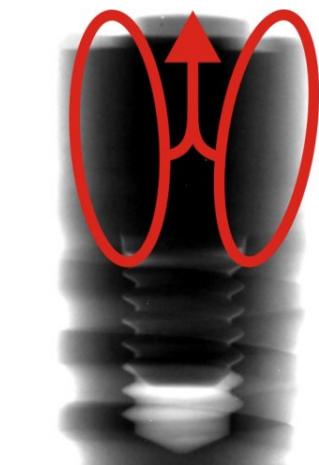
After 1.000.000 cyclic loadings

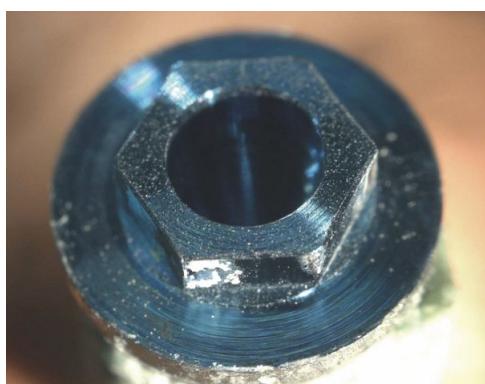
Bio-Horizons

Caused of Implant diameter (5mm) no failure detected
